Manhole Inspection Summary

Manhole # S31YY1016MH

Insp Date: **1/23/07 9:59 AM**

Location Address: **101 SAINT DUNSTANS RD**

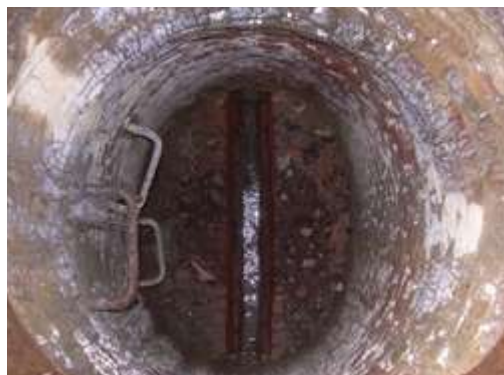
Top View

Corroded steps. Evidence of surcharge - Bench debris.

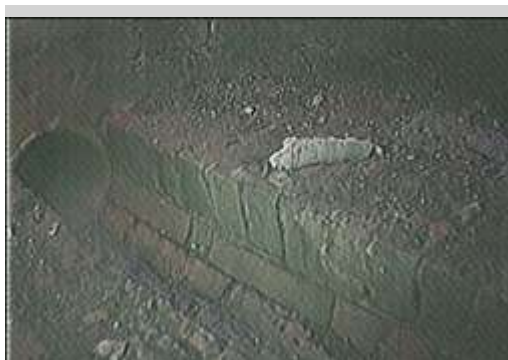
Defect

Barrel deterioration and infiltration. Channel deterioration.

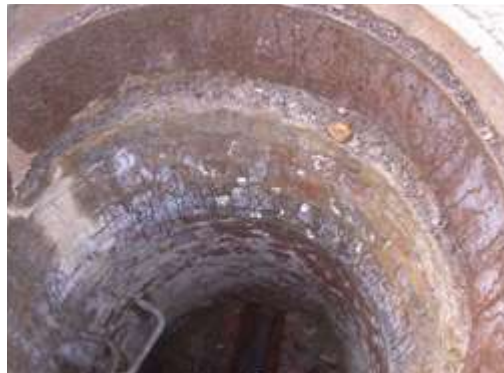
Defect

Frame leaks. Adjustment infiltration - other side.

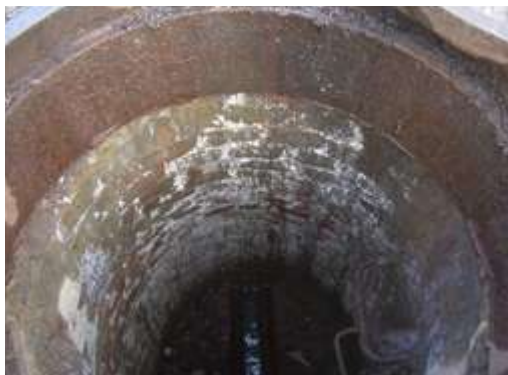
Defect

Frame leaks. Adjustment infiltration.

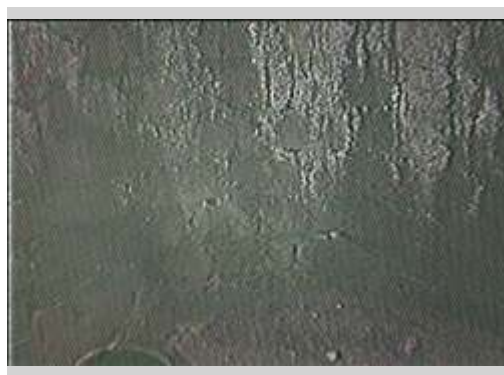
Defect

Barrel deterioration and infiltration.

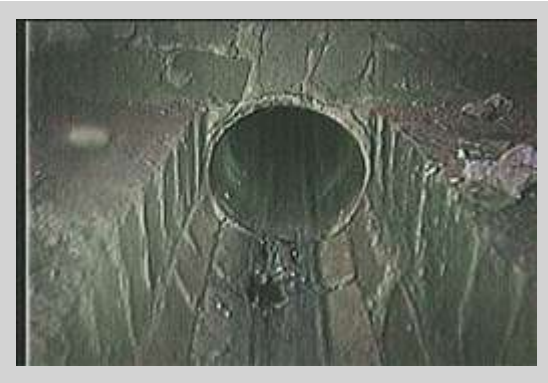
8 in. Circular Gravity Sewer Pipe Out @ 12 O'Clock

Channel deterioration.

Infiltration: **Evidence** Pipe Seal Cond: **Cracked**

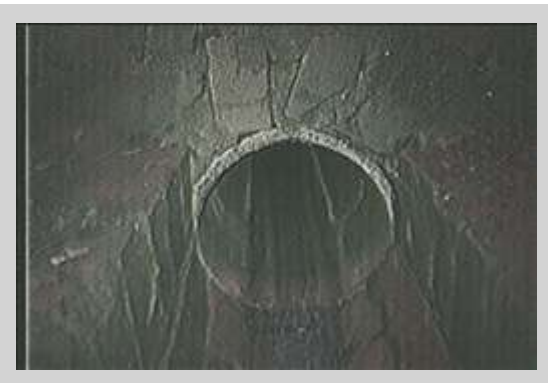
8 in. Circular Gravity Sewer Pipe In @ 6 O'Clock

Infiltration: **Evidence** Pipe Seal Cond: **Unknown**
